SOUTH FORK OF HILL CREEK BRIDGE
Texas Historic Bridges Recording Project
Walnut Springs City Park
(Moved from South Fork of Hill Creek at
County Route 2730, Walnut Springs Vicinity)
Walnut Springs
Bosque County
Texas

HAER No. TX-30

WRITTEN HISTORICAL AND DESCRIPTIVE DATA

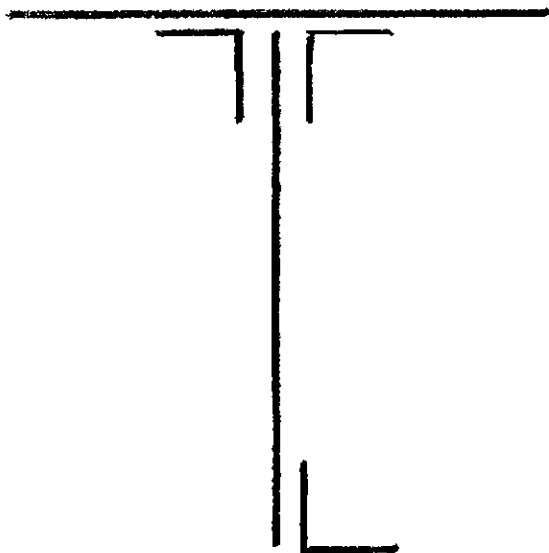
APPENDIX B: Schematic Cross-Section of Top Chords and End Posts (not to scale).

The South Fork of Hill Creek Bridge, approximately fifty-four feet long and thirteen feet wide, is a riveted double-intersection, three-panel Warren pony truss. The trusses are reinforced with knee braces at the top chord panel points in such a way that they could be mistakenly interpreted from a distance as the verticals of a Howe truss. These braces are apparently not original, however, because they are bolted to the deck stringers and are rather clumsily riveted into the top chord. Two braces are missing and many of the those remaining are twisted out of shape, presumably from automobile collisions. The trusses are about three inches out of parallel and the braces may have been added in a vain effort to address this problem. Until recently, built-up members attached to the inclined posts served as approach guard rails.
